WEAR AND DEGRADATION OF UHMWPE TOTAL HIP REPLACEMENT COMPONENTS

Michael Kipping, BEng(Hons.), MSc.

The University of
Nottingham

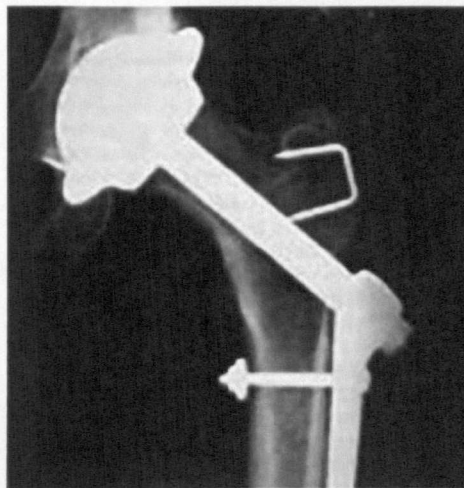
Figure 2-5 Wiles total hip replacement

In the late 1930's, Philip Wiles developed a total hip arthroplasty at the Middlesex Hospital in London. The all-metal prosthesis consisted of a cup that screwed into the acetabulum and a femoral stem bolted to the outside of the femur (Figure 2-5). In 1938, Wiles carried out the first total hip replacement. The technique was offered to patients who predominantly had juvenile chronic Arthritis and were bedridden or just able to walk. Results were stated as being 'only tolerable' in 25% of cases although a full explanation of the outcomes was not given [47].

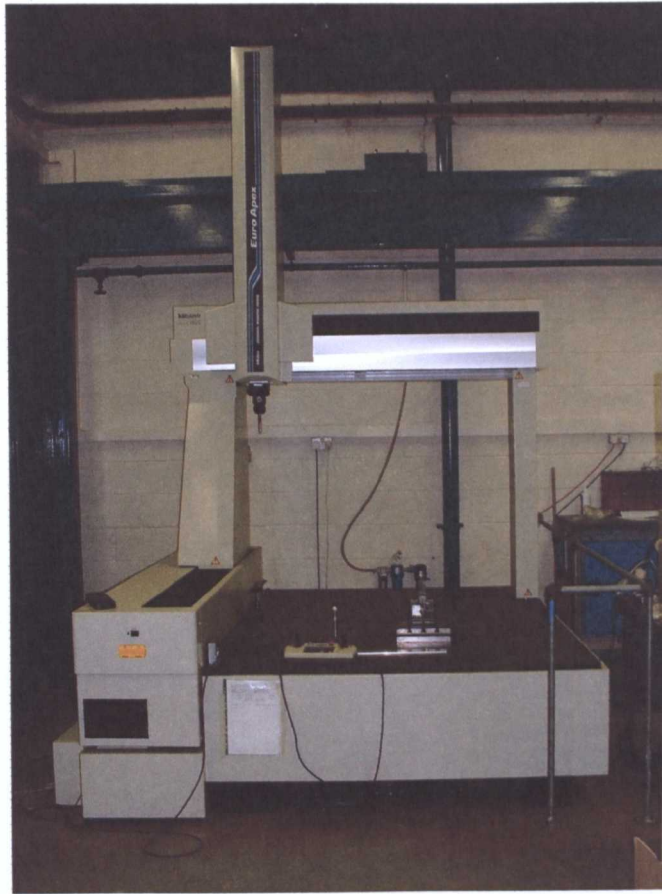
Co-ordinate measuring machines are used to obtain precise dimensional information from objects. CMM's are routinely used by orthopaedic component manufacturers to ensure that products are fabricated in accordance with design tolerances. In this study, a Mitutoyo Euro Apex coordinate measuring machine (CMM) (Figure 3-1) was used to evaluate the linear and volumetric wear of retrieved acetabular components.

Figure 3-1 Mitutoyo Euro Apex co-ordinate measuring machine (CMM)

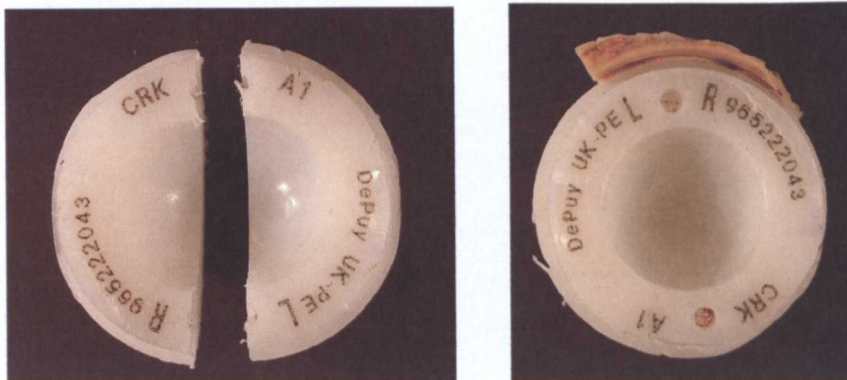
Figure 4-4 Sectioning of retrieved components

Components were sectioned through the regions of highest and lowest wear using a handsaw (Figure 4-4) along line (A-B) (Figure 4-3) in order to prepare through

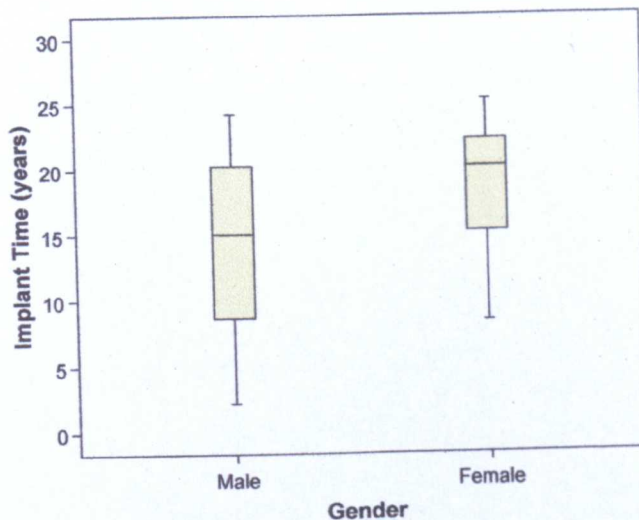
Figure 5-6 Boxplot of implantation time as a function of gender

37.5% (n=12) of components survived for > 20years. Components implanted in female patients survived longer than those in male patients. At 10 years, there was a 92.0% survival rate for females as opposed to 70.0% rate in males. At 15 years 76.9% components in females had survived against 52.6% in males. Only 26.3% of components in male patients survived for > 20 years whilst 53.8% survived in female patients. The mean implantation time for acetabular components is longer for female patients (18.39 ± 0.03 years) than male patients (14.20 ± 0.04 years) (Figure 5-6).
